CASE STUDY: NEW COPPER PENNY NIGHTCLUB

"When Good Projectors Go Bad"

Power Conditioning Saves The Day At An Oregon Club

SPECIFICATIONS AC-215A

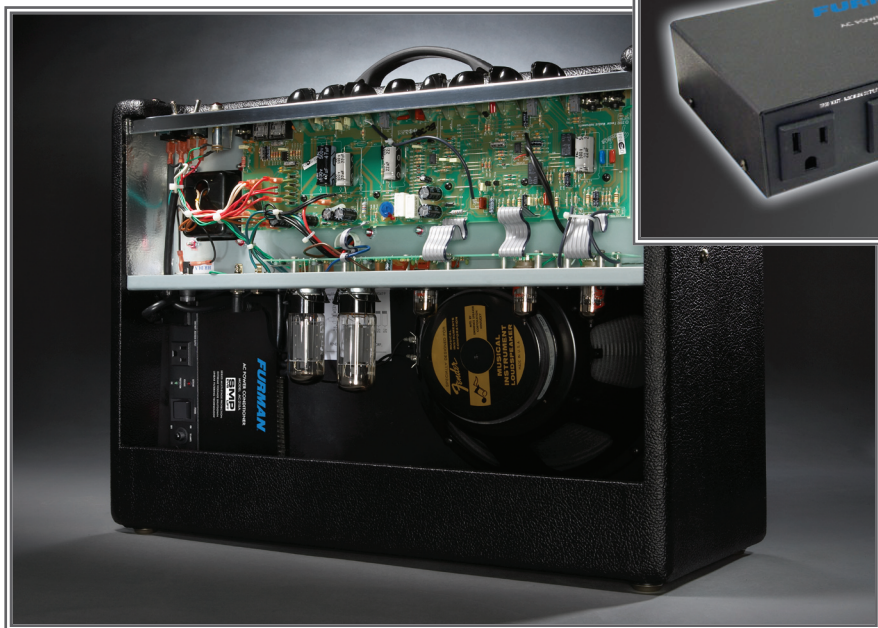
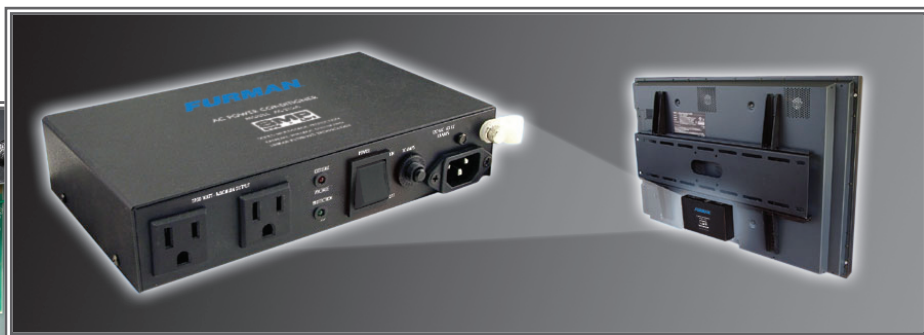
AC-215A mounted inside a guitar amplifier (left) and behind a flat-screen television (above). The slim, compact design is sleek and unobtrusive, allowing for ease of use and discreet mounting anywhere that clean, filtered power is needed.
